REVIEW OF ROCKBURST INCIDENTS AT THE MACASSA MINE, KIRKLAND LAKE

B. ARJANG AND G. NEMCSOK

DECEMBER 1986

MINING RESEARCH LABORATORIES
DIVISION REPORT MRL 87-21 (TR)

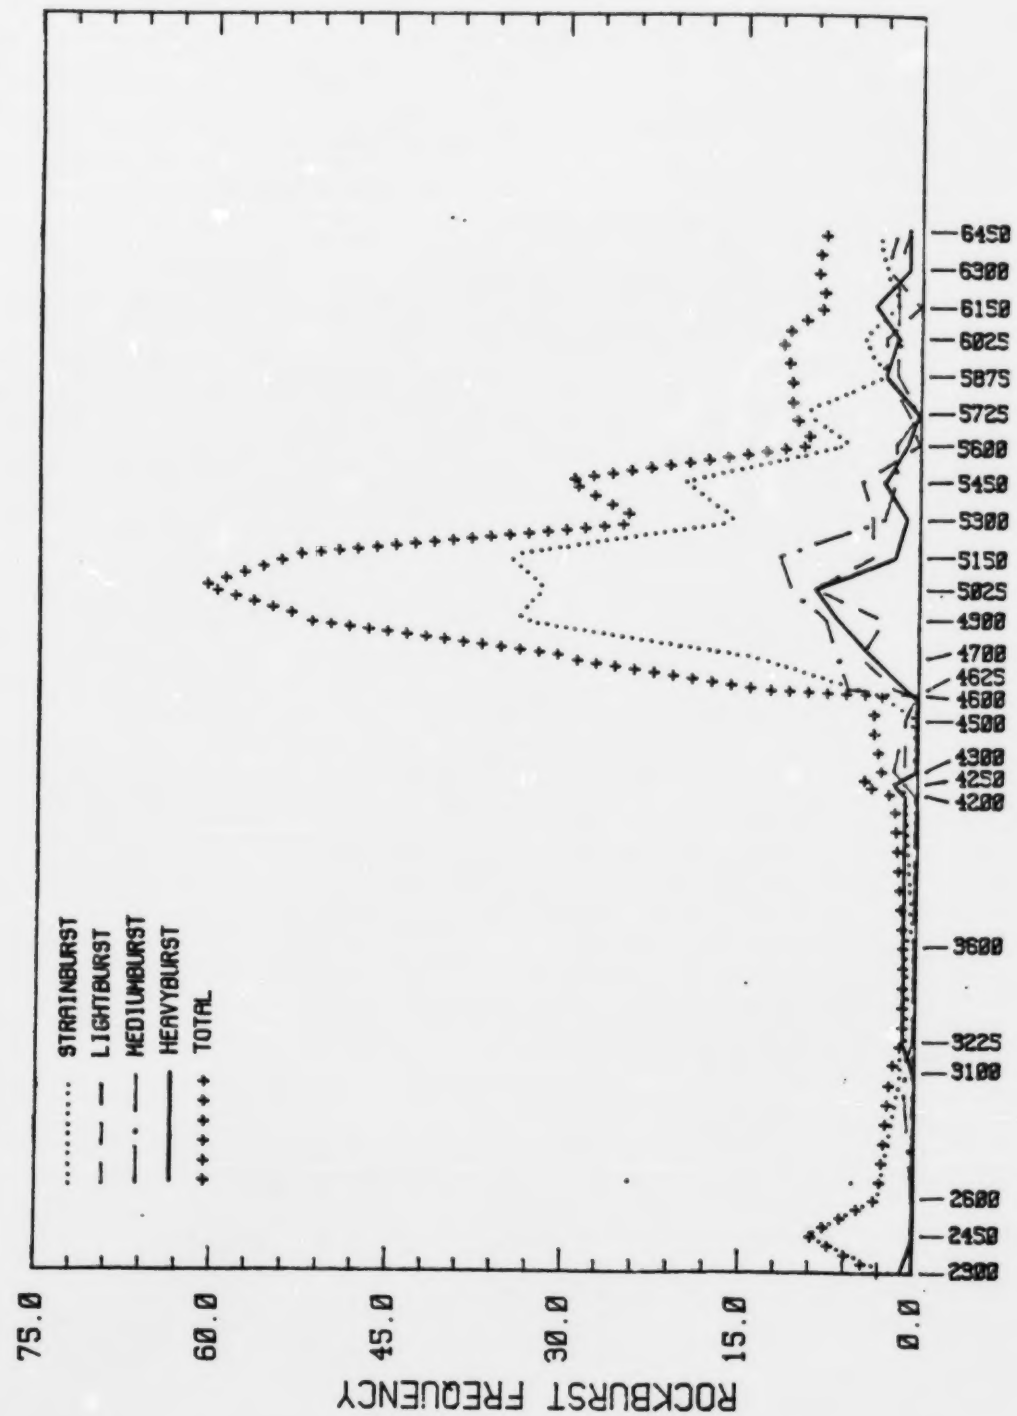
Rockburst events were reported from a depth of 670 to 1935 m below surface with a preponderance between 1400 to 1650 m reflecting where most mining was taking place. Figure 1 shows the rockburst frequency by working levels. The highest frequency was concentrated in the proximity of the 1500 m level.

Fig. 1 - Distribution of rockbursts by working levels, Macassa Mine.

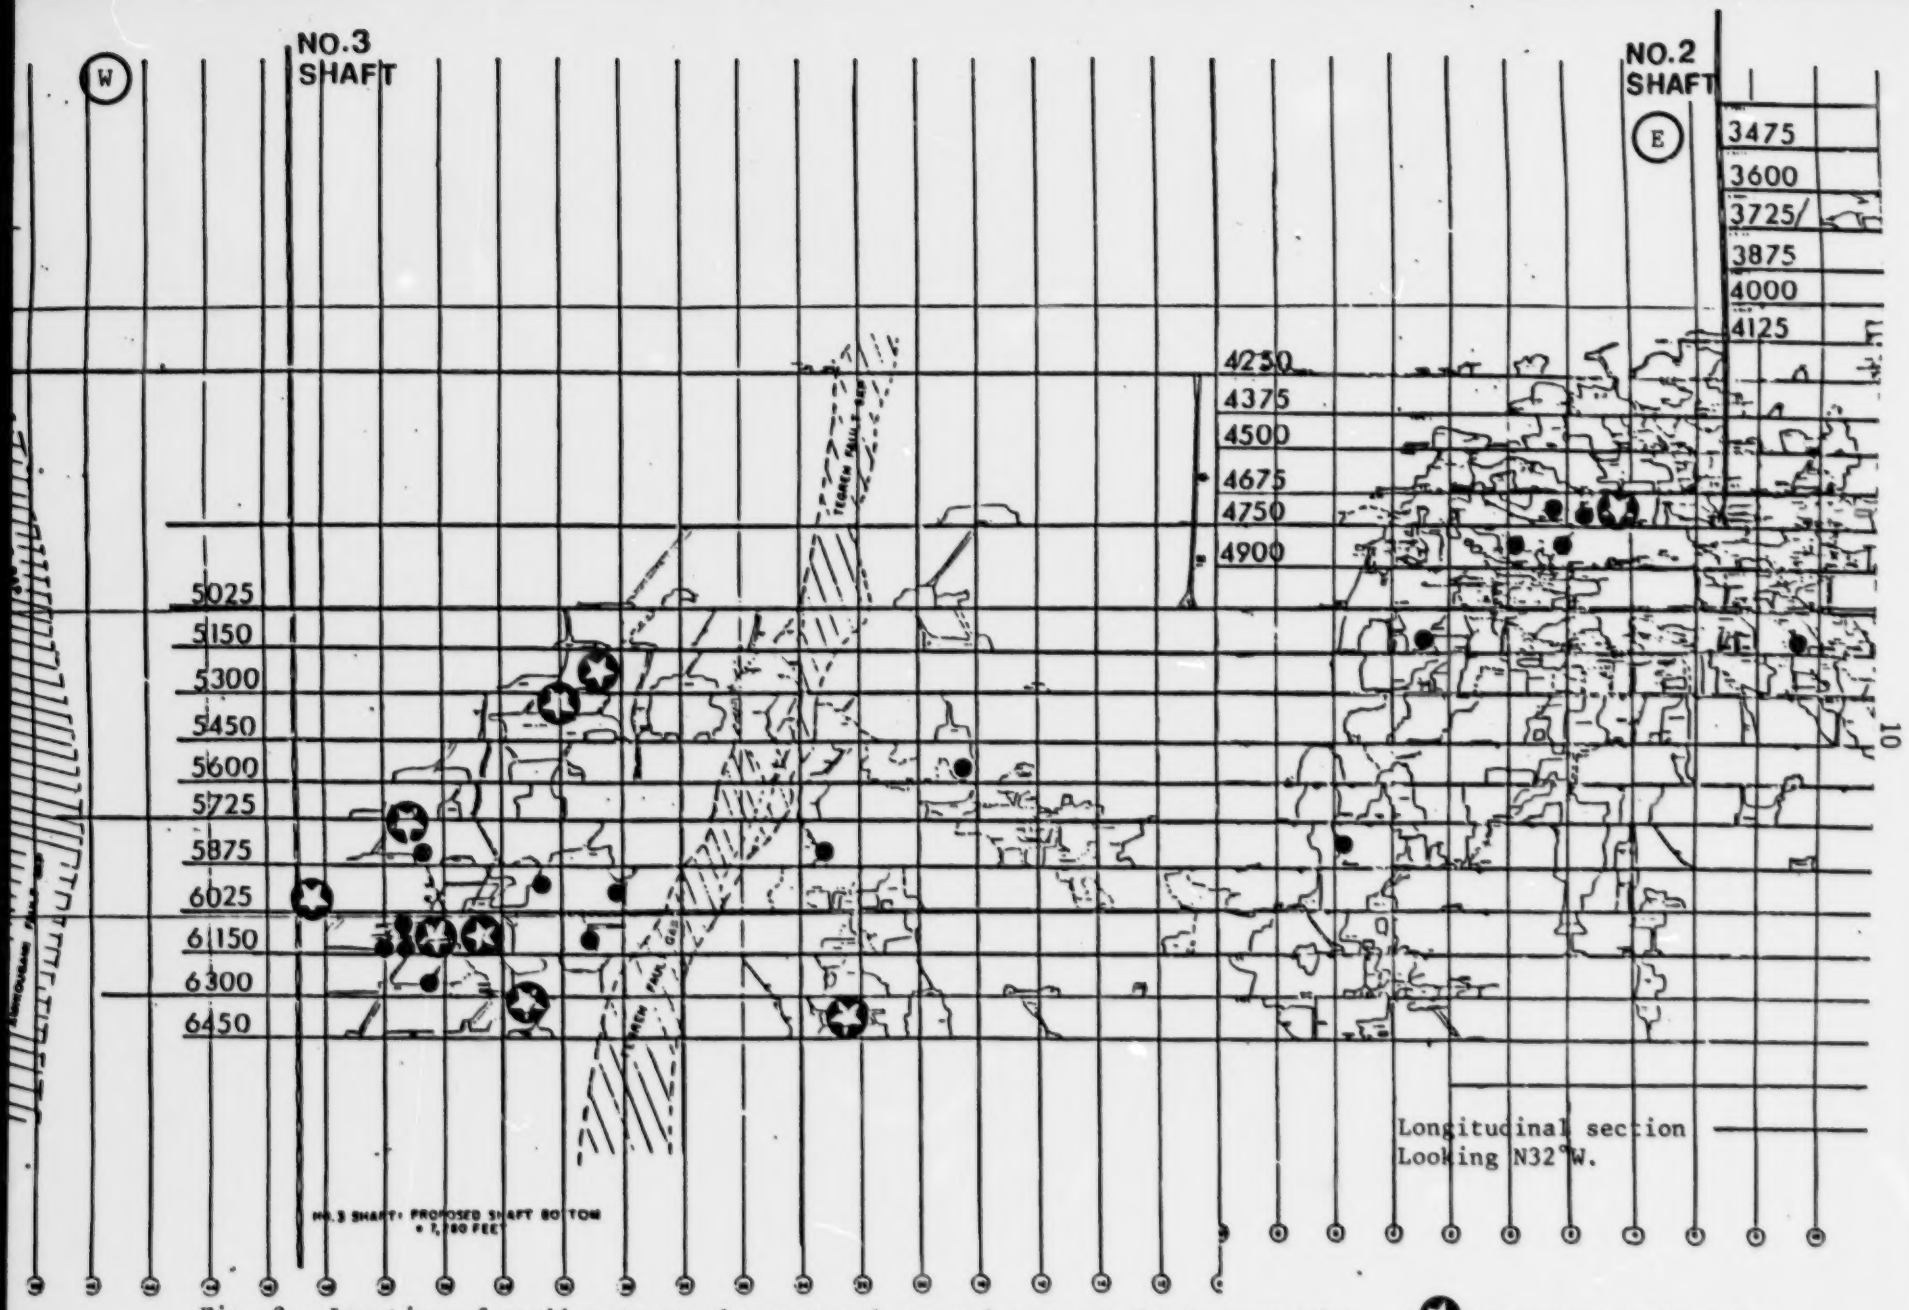
Figure 2 shows the location of rockburst events recorded on the Eastern Canada seismic network, and the distribution of "heavy rockbursts" from visual observations.

Fig. 2 - Location of rockbursts on the west and central area at the Macassa Mine. (✪) Recorded rockbursts, magnitude 2.2 to 3.1 MN. (●) observed "heavy rockbursts", rock displacement >50 tons.
